Seven Years in the Life of a TSB Investigator - Part 5

#11 Even Safety Nets Can Kill

#12 The Heli-Skiing Accident

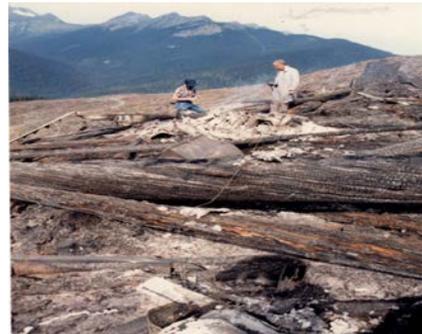
low rotor horn sounded and as he reiterated to me on his death bed, *"I had the collective in my armpit."* The helicopter came straight down on the now "pickled" (released) drum and into the fire. The crash punctured a hole in the aircraft fuel tank releasing more fuel to the now raging fire. He released his seat belt and jumped into the fire and managed to

crawl over the burning logs and out of the fire. Another helicopter drip torching nearby saw the burning helicopter and flew over. He said that the pilot had all his clothes burnt off of him except a bit at the top of one leg. His skin looked like bacon crust and every joint that he moved, caused the skin to crack open and clear fluid came out. He flew him to the nearest

However, Bell had issued a Technical Bulletin (#206-82-71) which stated that "*failure of the engine N1 tachometer generator causes the engine out audio warning horn to signal an erroneous engine failure, which has occasionally confused the pilot, causing an improper control response. In several recent cases, the N1 tach generator failed and the engine-out warning horn activated. The pilot hearing the horn surmised he had an engine failure and elected to go with emergency landing procedures. The aircraft auto-rotated into undesirable terrain.*" The Technical Bulletin goes on to suggest that the fix (Safety net) for the problem is to deactivate the warning horn and placard the instrument panel, with a decal they will provide, that informs the pilot that the engine-out warning horn is deactivated. This Technical Bulletin had been carried out a week earlier and with it a new deadly hazard was created. A flame-proof Nomex suit and helmet also likely would have enabled him to at least survive.

The **moral** is to take that minute for Safety and weigh the risk for either option. Technical bulletins are not mandatory and training to look at other instruments beside the N1 should the horn sound would prevent the "*auto-rotating into undesirable terrain.*"

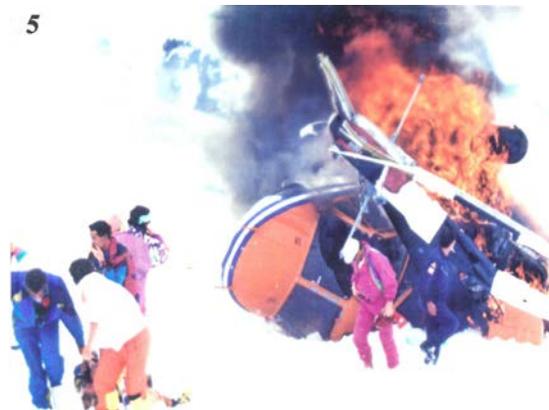
However, a fire immediately started that resulted in 3 fatalities. The fire was due to a 90 degree aluminum fuel fitting breaking and releasing fuel under pressure that immediately ignited. It was attached to a steel fitting at the firewall and had it been made of stainless steel it would have been 8 times

stronger and much less likely to fail. Remember the DC3 (story #4) that failed due to an aluminum fitting that if it had been made of steel like the rest, the old girl might still be flying.

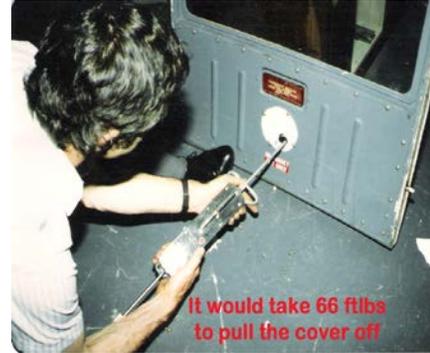
You be the judge regarding maintenance whose error may not have contributed but very well could have. The cover over the emergency exit handles are made of plastic that, as they vibrate, wear and begin to fall off. It seems that on other aircraft as well as the accident one, a keen AME put washers under the holding screws so the covers would not fall off. Tests carried out on the modified cover revealed that it now took 66 ft lbs to remove the cover.

Imagine having one finger in the one inch hole and having to pull 66 lbs to remove it. One person did put his finger in one but he tried to turn it without success. The other maintenance error that could have contributed to fatalities was the headrests were all fitted with pippins (quick release pin) that allowed the headrests to be adjusted for height and to go down and turn sideways in an emergency. One was fitted with a bolt and self-locking nut. No one knew how to lower the headrests because they had not paid attention to the Safety video.
